Parker, David, and Tilton Ponds WATERSHED SURVEY

Summary Report

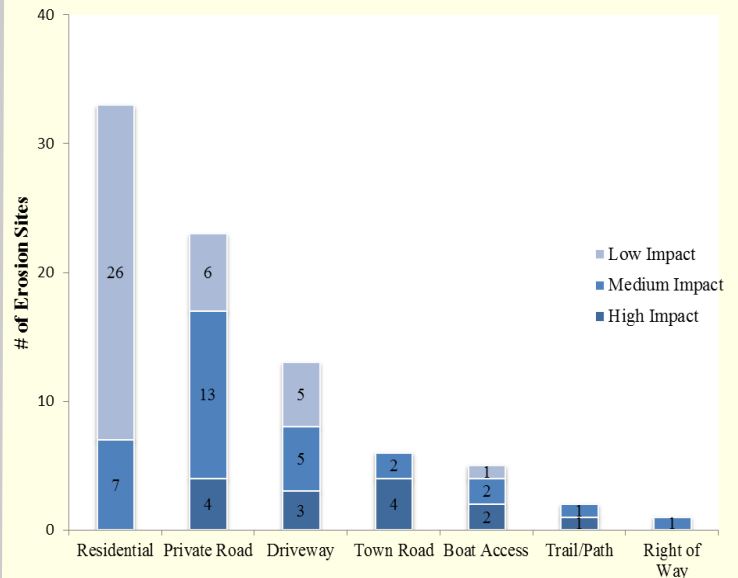
Erosion Sites by Land Use

- 45 of the identified sites (55%) were found in residential areas (32 residential, 13 driveway). The majority of these sites (30) had less severe erosion and can be fixed easily at low cost. Individual landowners can play a big role in helping address these problems.

- 23 of the identified sites (28%) were associated with private roads (6 low impact, 13 medium and 4 high). These sites tend to be larger erosion problems with greater impacts on water quality. In most cases, comprehensive planning by a road association is critical to ongoing road maintenance.

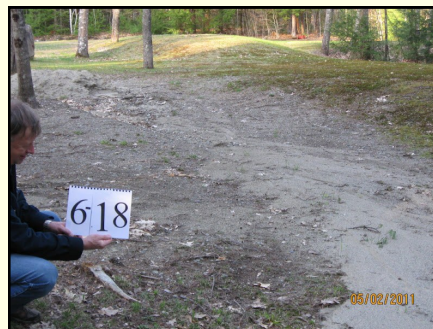
Example of moderate surface erosion identified on a residential site.

The full report provides information about how landowners can find support in addressing erosion issues on their properties.
