Flying Pond Watershed Survey Summary Report

BACKGROUND:

Over the spring and summer of 2014, the 30 Mile River Watershed Association, with the support of its partners and trained volunteers, conducted a watershed survey of Flying Pond, near the head of the 30 Mile River watershed in Central Maine. The purpose of the survey was to protect and improve water quality in these lakes by (1) identifying and documenting potential sources of pollution from erosion and runoff and (2) recommending solutions to fix the problems.

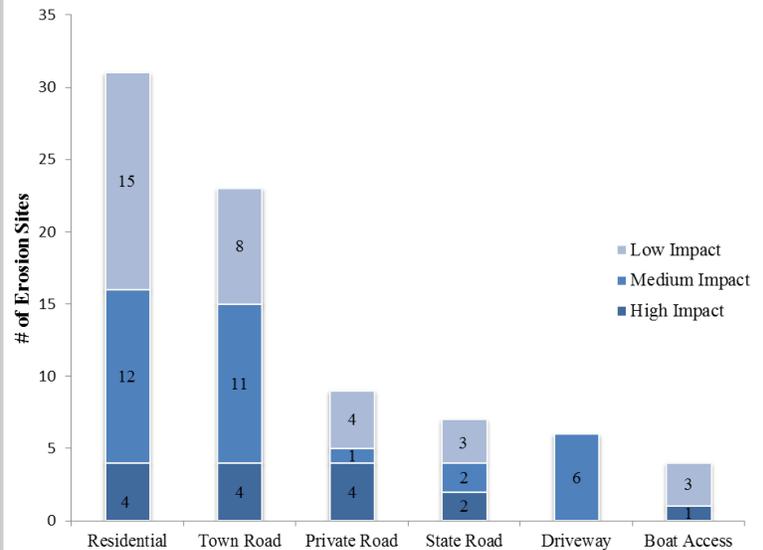
Erosion Sites by Land Use

- ◆ 31 sites (37%) were classified as a *residential land use*. Another 6 sites (7%) were identified as *driveways* located on residential properties.
- ◆ 23 sites (27%) were associated with *town roads*, including 13 paved and 10 dirt surfaces. Many of the problems identified at these sites are the result of the migration of winter (deicing) sand from the road surface into roadside ditches, or directly into nearby streams, and from erosion of exposed soil along road shoulders and in roadside ditches.

- ◆ 9 sites (11%) were associated with *private roads*. These included 4 low impact, 1 medium impact, and 4 high impact. Remediation of private road sites usually requires the cooperation of a road association or group of owners. Comprehensive planning by road associations is critical for proper, long-term road maintenance.

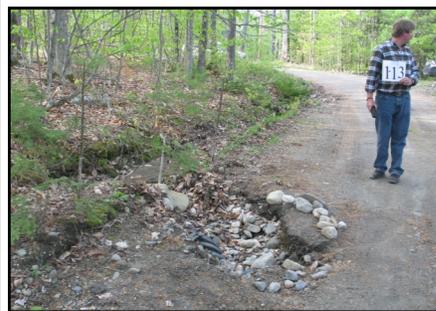
Example of severe surface erosion identified on a private road.
